# KODAIKANAL BASELINE STUDY FOR URBAN SANITATION

*January 2019*

This document is produced as part of Tamil Nadu Urban Sanitation Support Programme (TNUSSP). TNUSSP supports the Government of Tamil Nadu (GoTN) and cities in making improvements along the entire urban sanitation chain. The TNUSSP is being implemented by a consortium of organisations led by the Indian Institute for Human Settlements (IIHS), in association with CDD Society, Gramalaya, and Keystone Foundation.

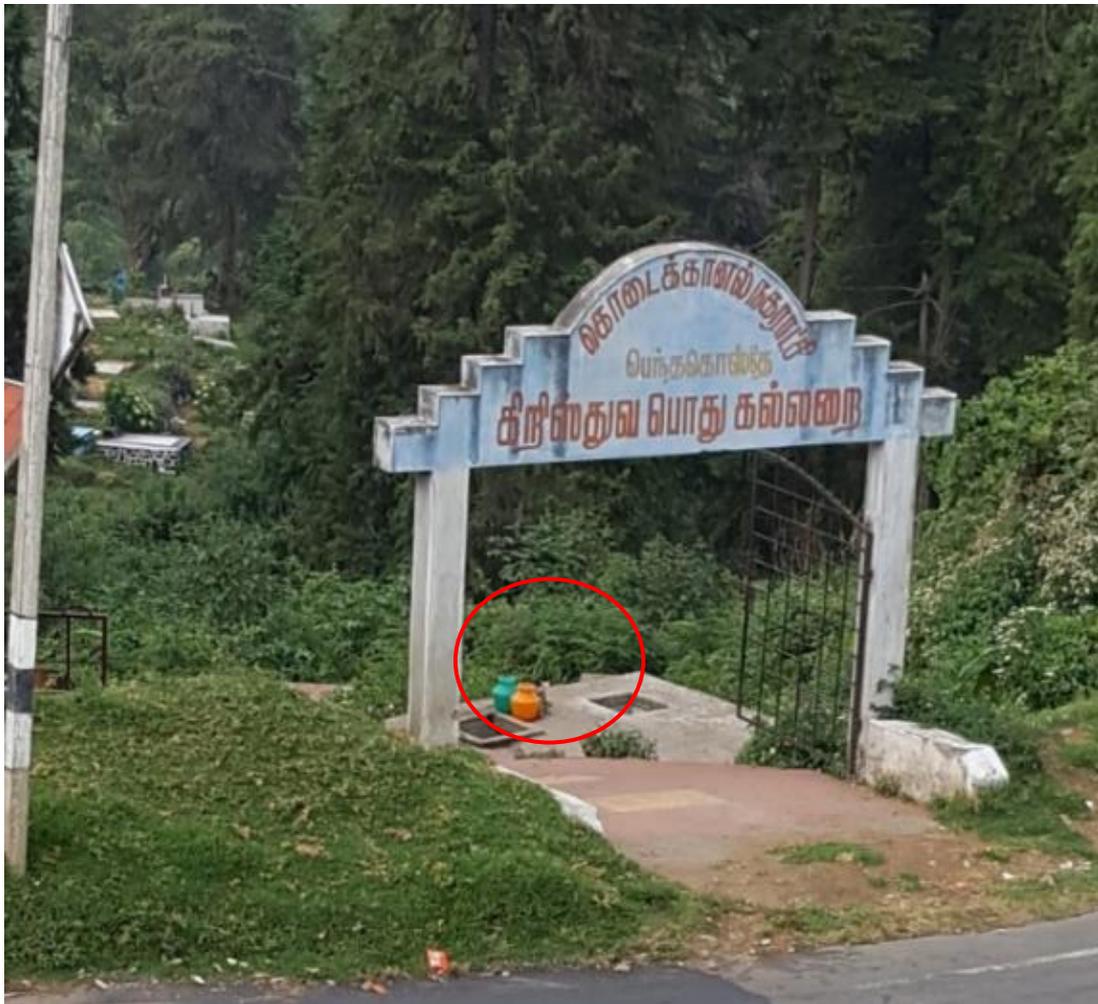
Figure 3.6: A Spring Located in Anna Nagar

Economic levels among households played a large role in access to potable and non-potable water. While the high and middle income groups depended largely on private vendors for drinking water such as 25-litre capacity bubble tops priced between Rs.50/- to Rs.70/- a can, the low-income groups usually stored the municipal piped water in huge plastic barrels. Additionally, they depended on water sources like springs and private wells for bathing and washing clothes.

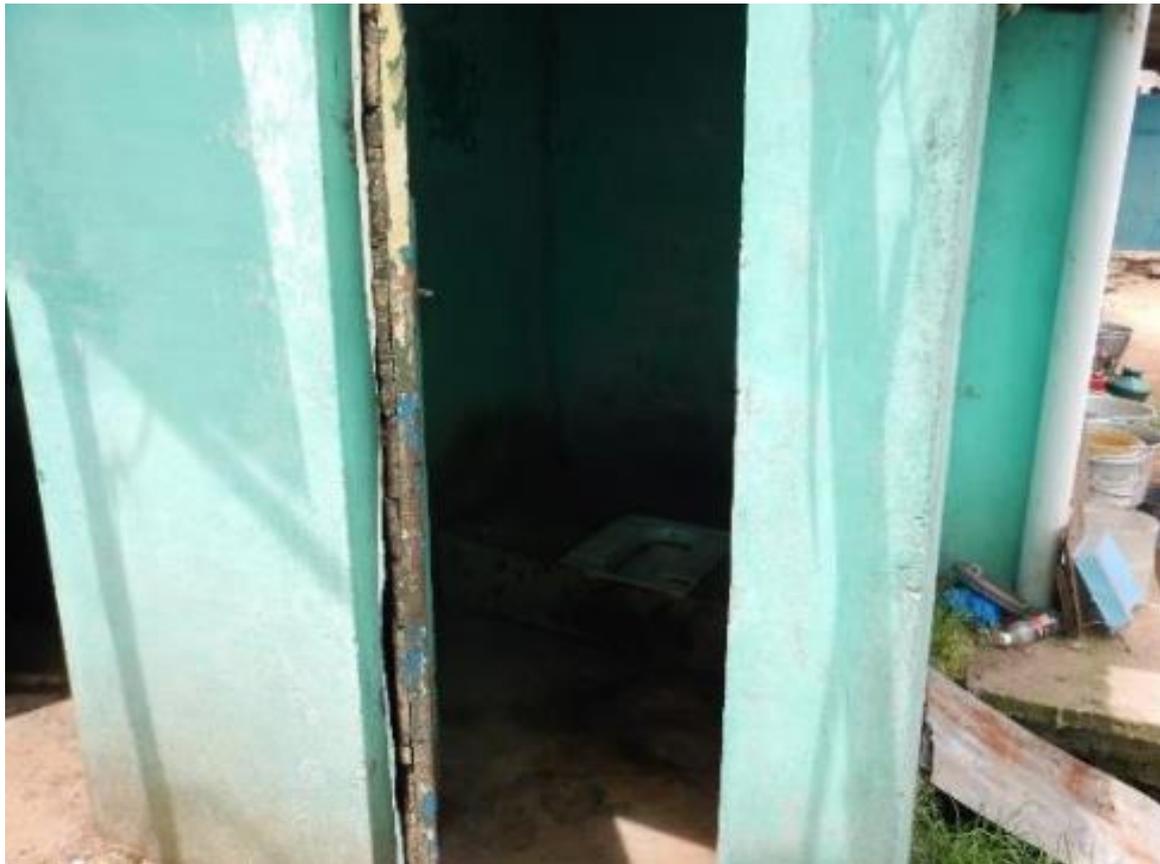
Figure 3.8: Individual Household Toilet

During the primary study, the team interacted with households in different parts of the town to understand the sanitation arrangements currently in place among households. It was generally observed that the majority of households had an independent toilet within their premises. The most common toilet type was the Indian style pour flush latrine. Western closets were also used in high and middle income households.

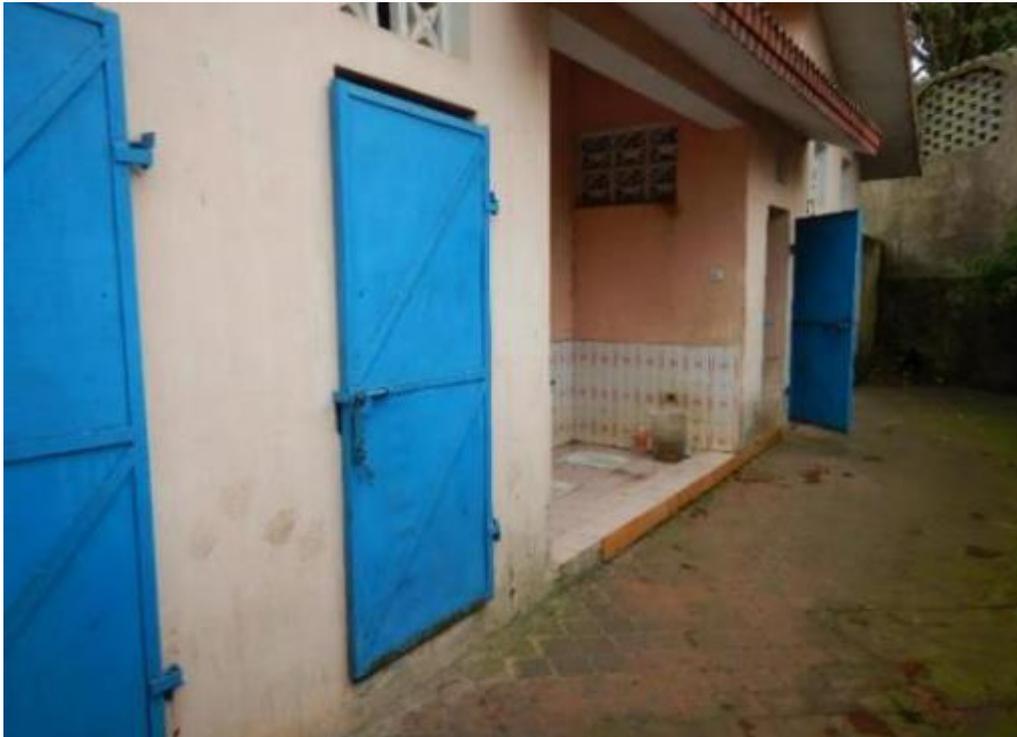
Figure 3.10: Public Toilet in Pakkiyapuram

All except one toilet block located inside the bus complex were single-storied. The general condition of the toilet structure was observed to be 'average'; that is, structure is intact but some deterioration in concrete, doors/locks coming loose and some repair were necessary. Most of these toilet blocks assessed were more than 10 years old.

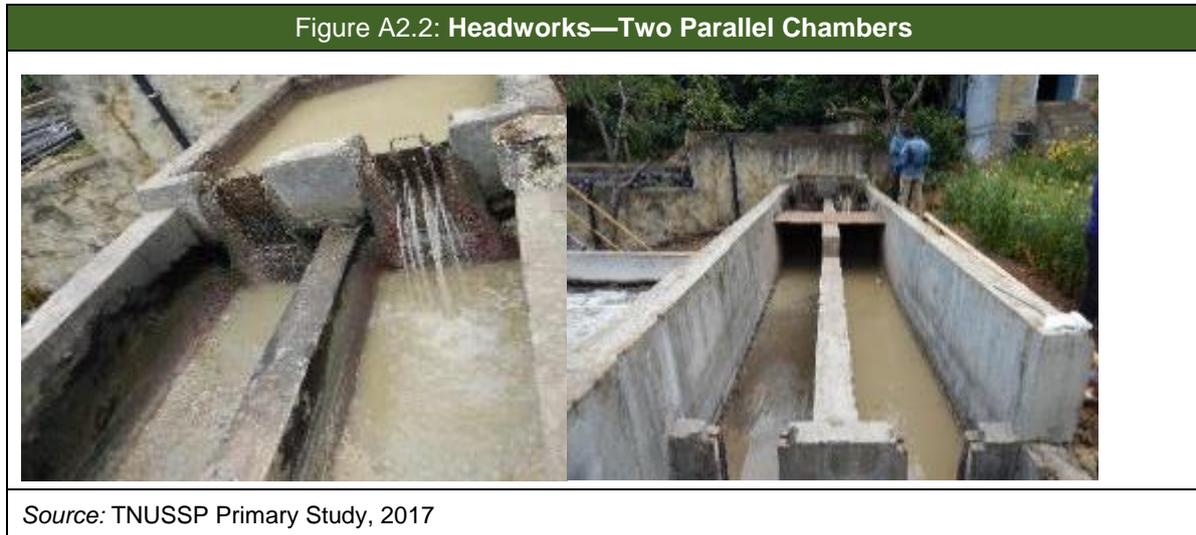
The headworks consist of a rectangular receiving chamber, with two sets of grates at one end to allow flow of wastewater into the screens. The inlet pipe is buried under the receiving tank. There are two parallel channels with screen and grit removal chamber. One of the grates on the receiving chamber allows more flow to pass through than the other, and there is unequal flow distribution between the two screen/grit chamber channels, with one receiving less flow than the other, and at low flow times (early morning), not receiving any flow at all.

- The screens are coarse screens which have been supplemented by an additional mesh to improve screening.
- There is significant silt build-up in the grit channels—almost half the total depth appears to be filled with silt reducing the available capacity and decreasing grit removal efficiency of the channels.

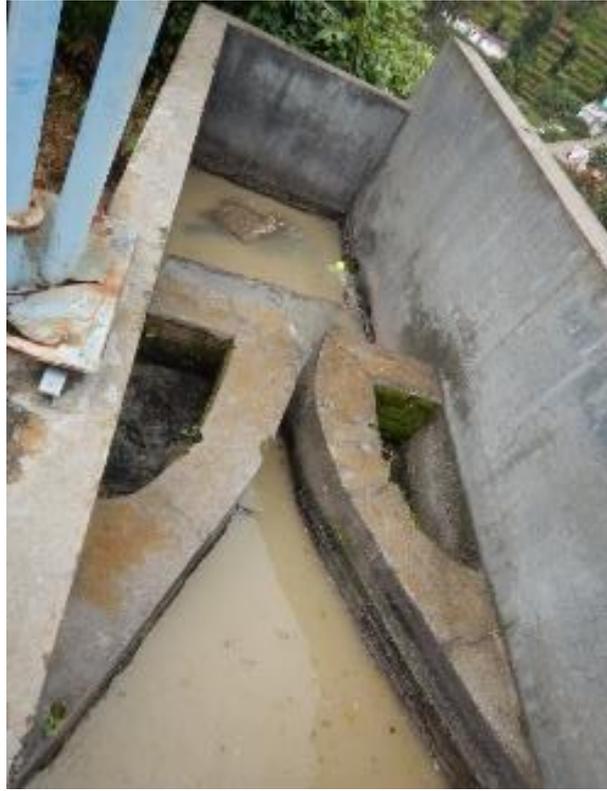
Figure A2.3: Parshall Flume

- There is a parshall flume which has never been used by the operator. There are no records of incoming flow volumes maintained for the STP. There is no documentation available on the specifications of the parshall flume. However, measurements made by the IIHS team indicated the parshall flume to have a 3" neck at the narrowest section. There are no markings to indicate the location where depth measurement should be made to quantify flow using the parshall flume. The downstream portion of the parshall flume has a step decrease in the flow level.
