Improvements to Existing Onsite Sanitation Systems: Demonstrations of Technologies

Report | November 2025

CWIS
TRICHY

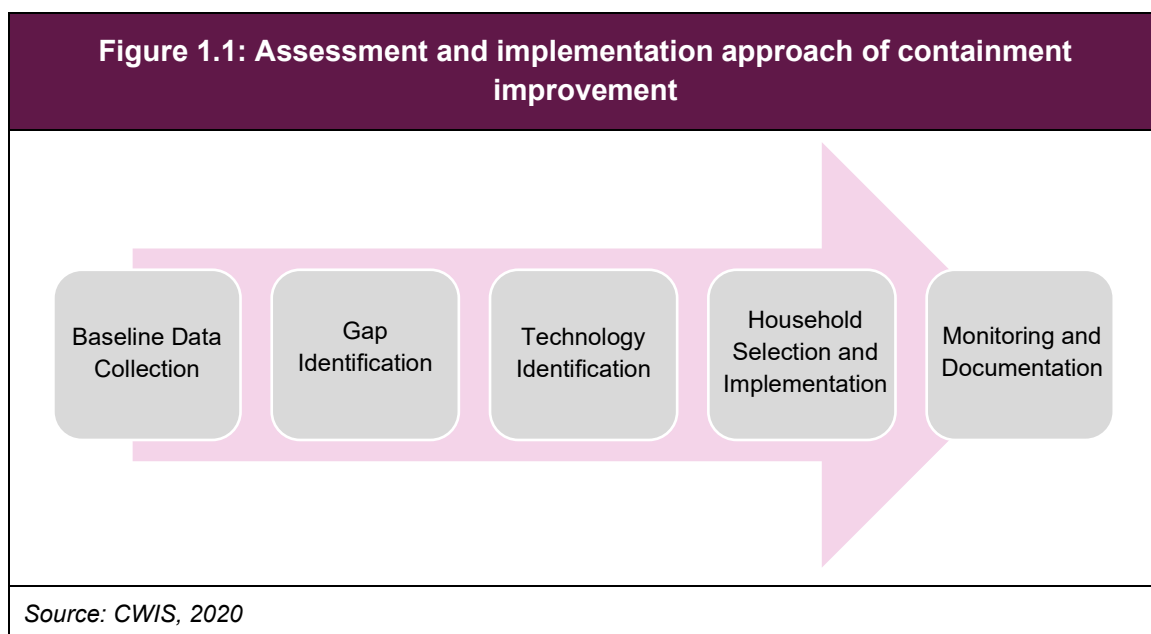
The methodology followed in the study is depicted in Figure 1.1.

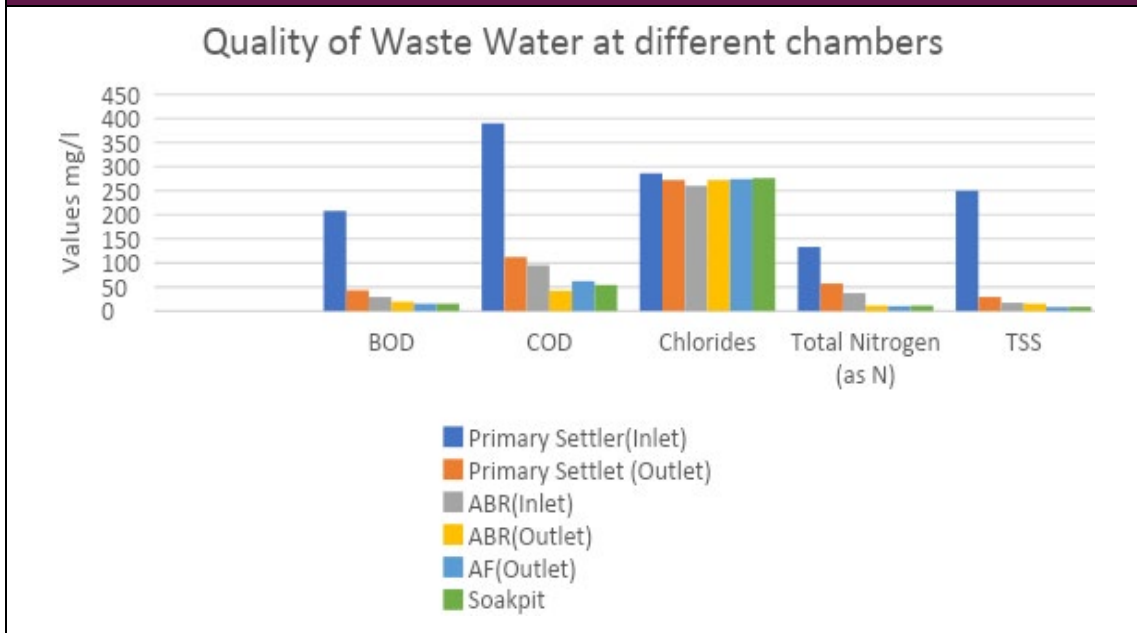
Figure 3.3: Performance efficiency of improved septic tank

The quality of the treated water in the containment was monitored between February 2021 and February 2023. The results showed that biological treatment in the improved septic tank was effective. The high concentration of COD and BOD in the primary digester was significantly reduced after treatment in the ABF and AF. Till 2024

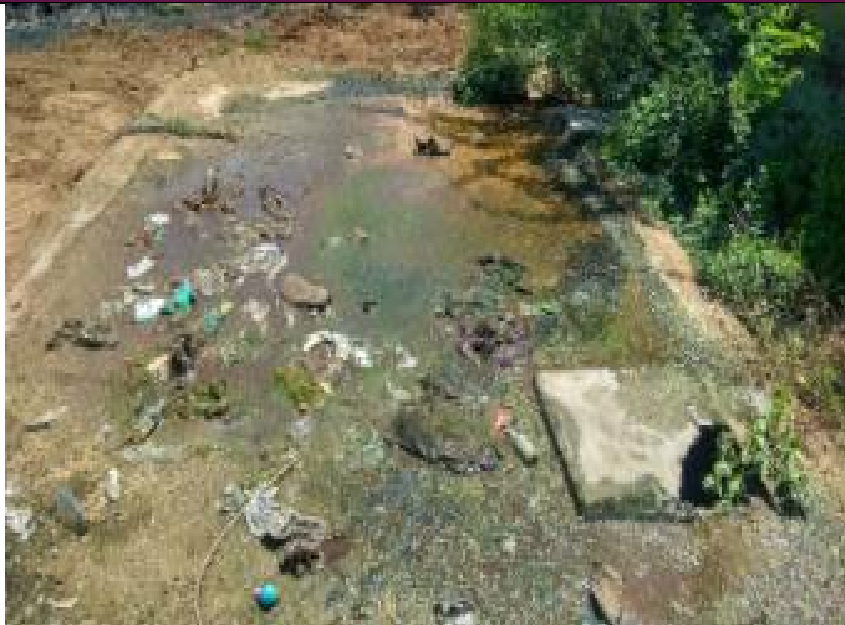
Figure 3.7: Status of containment before intervention in Thulasinganagar

Initial assessment of the containment showed leakage, frequent de-sludging, and huge sludge accumulation.

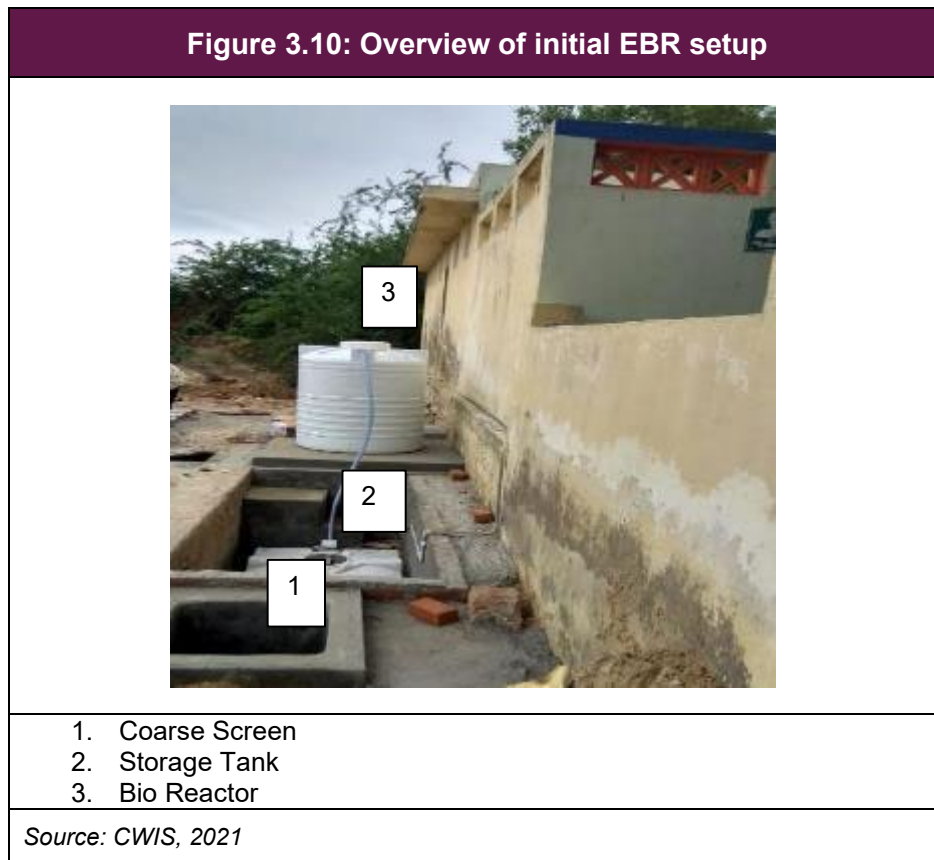
The HRT of the wastewater in the bioreactor was calculated by noting the time taken for the water to pass the bioreactor, and was found to be 30-45 seconds and 2-3 minutes before and after placing the

distribution arrangement, respectively. The components of the initial setup of the system are shown in Figure 3.10.

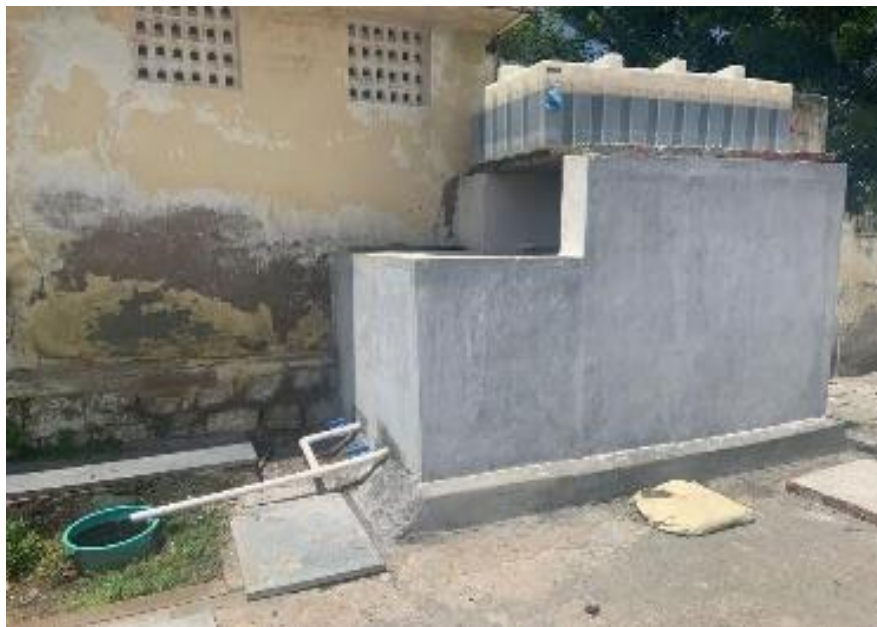
Figure 3.12: Current upgraded EBR at Thulasinganagar

The field implementation is shown in the Figure 3.12 below.

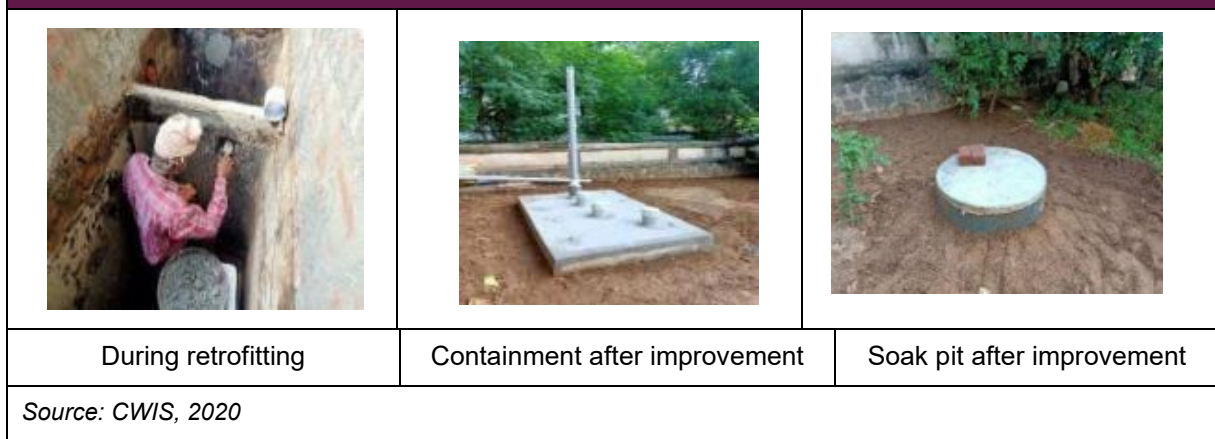
Figure 4.2: Status of containment at Srirangam during intervention

Firstly, a single pit was constructed to divert the septic tank inflow during the implementation of the new unit. This was de-sludged, cleaned, and converted to a soak pit. The time taken for field implementation was eight days. In accordance with IS 2470, major refurbishments provided were baffle wall openings at the top, T pipes, sloped bottom, vent pipes, and raised side wall. The stages of containment improvement are provided in Figure 4.2.

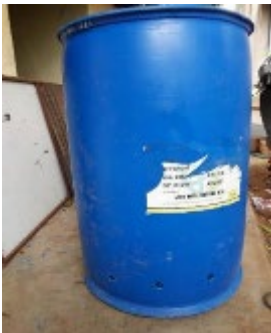
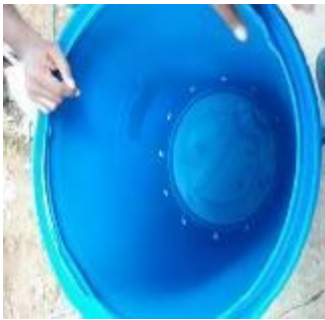
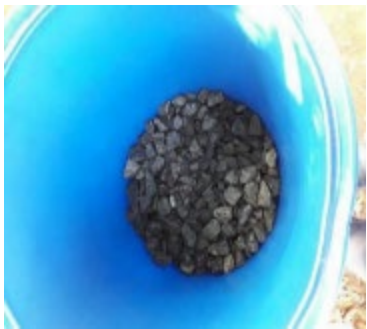
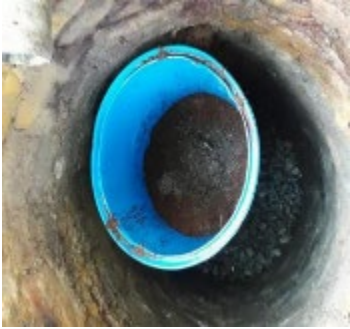
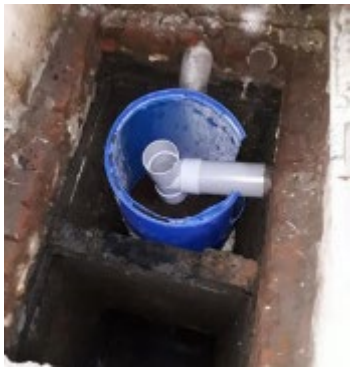
Figure 4.10: Preparation of an EBR

<p>PVC drum with drain holes</p>	<p>Inner view</p>	<p>Drainage layer</p>

<p>Drainage and mesh layer</p>	<p>Installation after addition of earthworm-vermicompost mixture</p>	<p>Bioreactor after installation in the containment</p>
<p>Source: CWIS, 2020</p>

EBR was assembled in a plastic barrel capacity of 200 litres of 55-centimetre (cm) diameter and 80 cm depth, and the effluent from the barrel was drained through a layer of washed aggregates (10-15 cm thick). Holes were provided throughout the circumference of the barrel at about 10 cm from the bottom. The earthworm-vermicompost mixture (a combination of *Eudrilus eugeniae* and *Eisenia fetida* species) was introduced after the barrel was placed in OSS. Cocopeat blocks with low electrical conductivity (EC) were used as the active biological layer. For a better understanding, the steps involved in the preparation of EBR is provided in Figure 4.10.

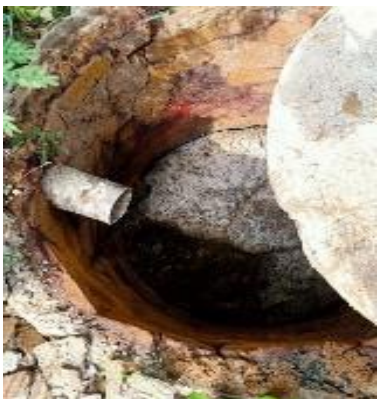
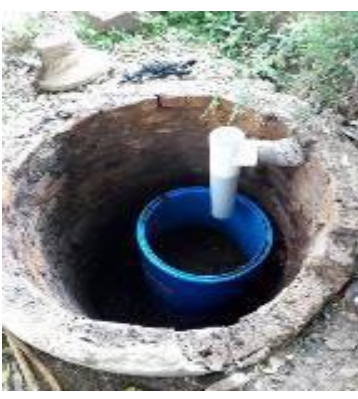
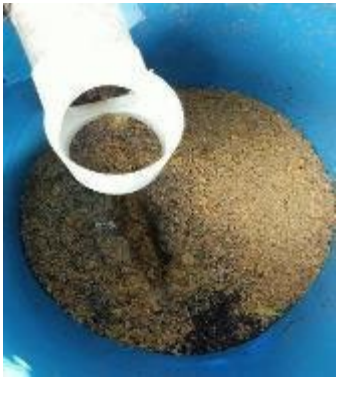
Figure 4.14: EBR at Ponmalai

Containment before improvement	During implementation	Failed system with stagnation
Source: CWIS, 2023

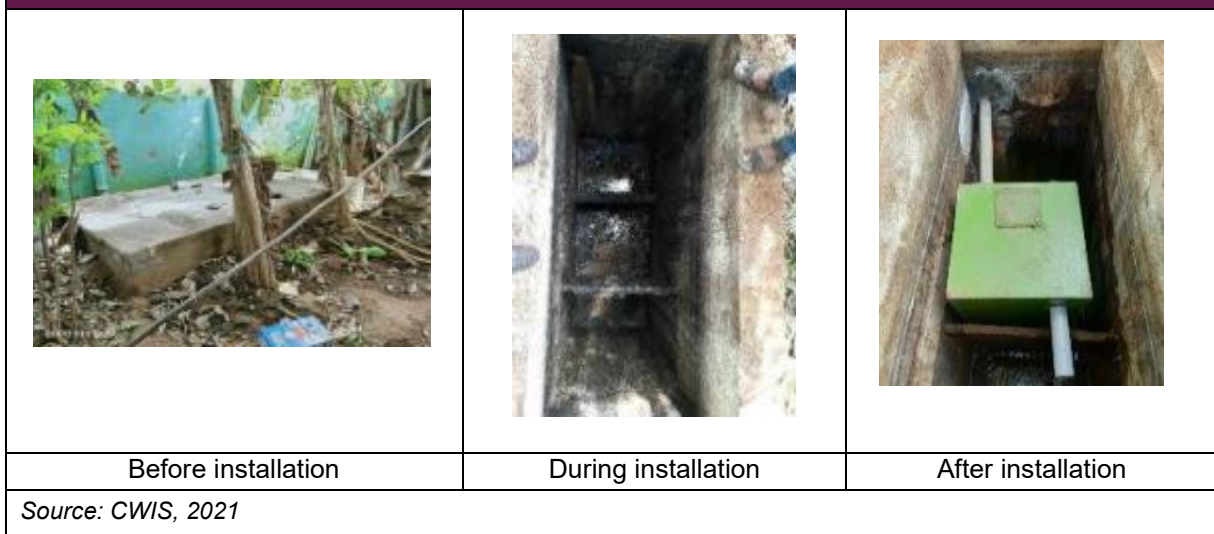
Figure 4.18: DRDO Biodigester at Alpha Nagar, Karumandapam

The implementation of the interventions at the selected households is shown in Figures 4.17, 4.18 and 4.19.

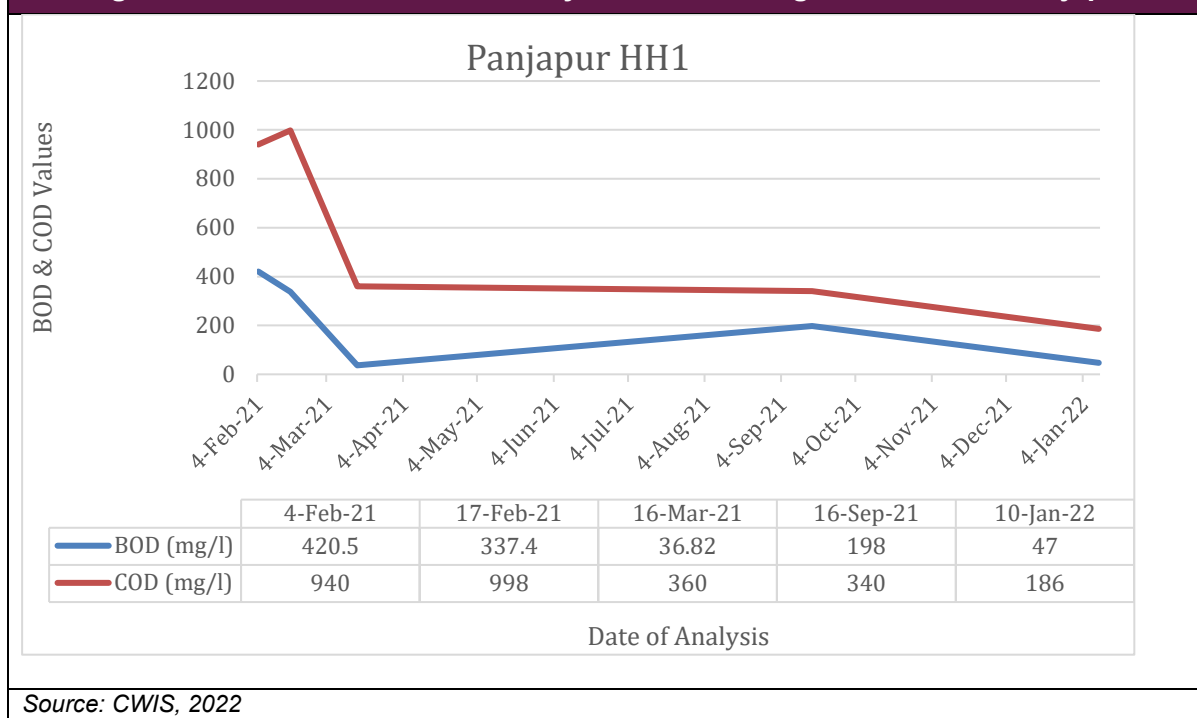
Figure 4.22: Performance efficiency of DRDO Biodigester at Keela Panjapur

Figures 4.20, 4.21 and 4.22 show the performance efficiency of the intervention at the respective sites.

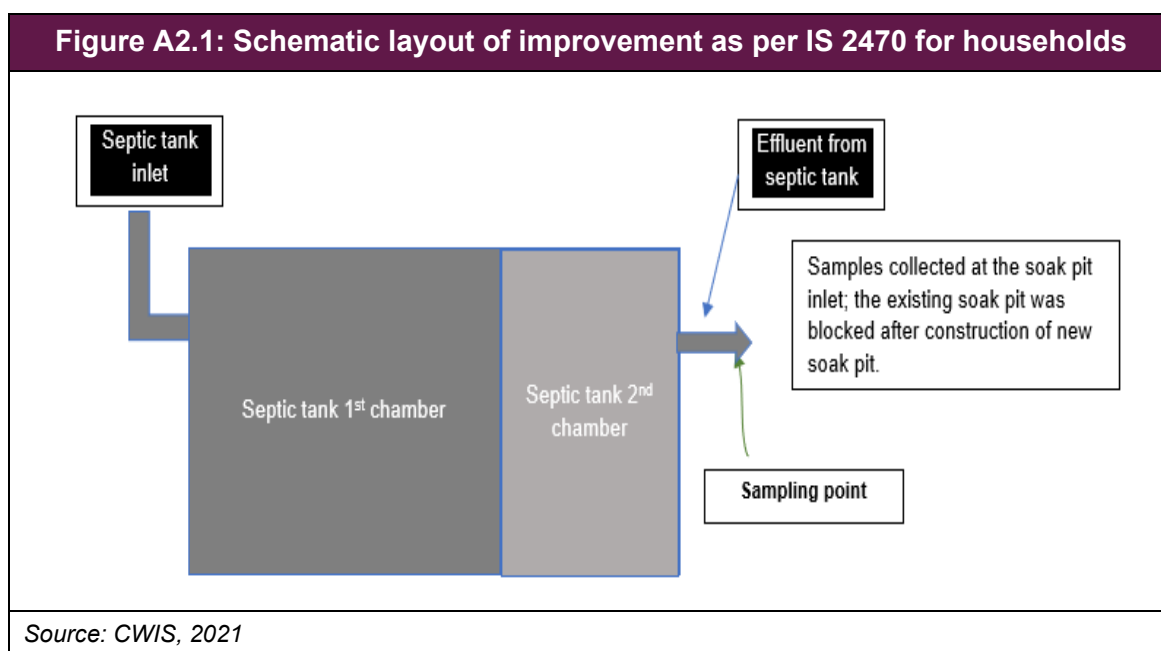
The containment was as per IS 2470 with provisions of baffle wall openings at the top, T pipes, slope at the bottom, and vent pipes. The raising of the side wall was also done as per the recommendations. The schematic layout of the improvement is depicted in Figure A2.1 below.

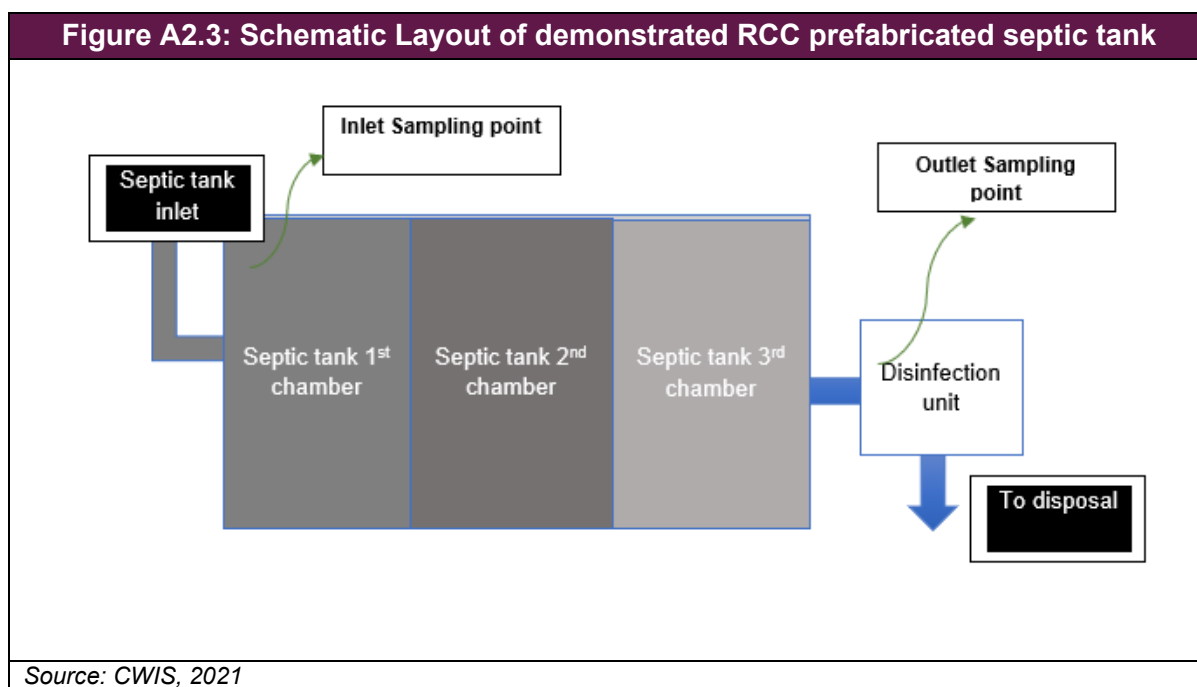
The prefabricated septic tank is a circular pipe made of RCC NP3 grade. Two partition walls at an equal interval of 0.83 m are present. The outlet from the toilet is connected to the inlet provision of the tank, allowing sludge to settle at the bottom and treated water is allowed to flow into the outlet chamber to the open drain by gravity. To improve effluent quality by disinfecting pathogenic organisms, an electro-chlorinator was installed in the outlet chamber. The schematic layout of the improvement is depicted in Figure A2.3 below.

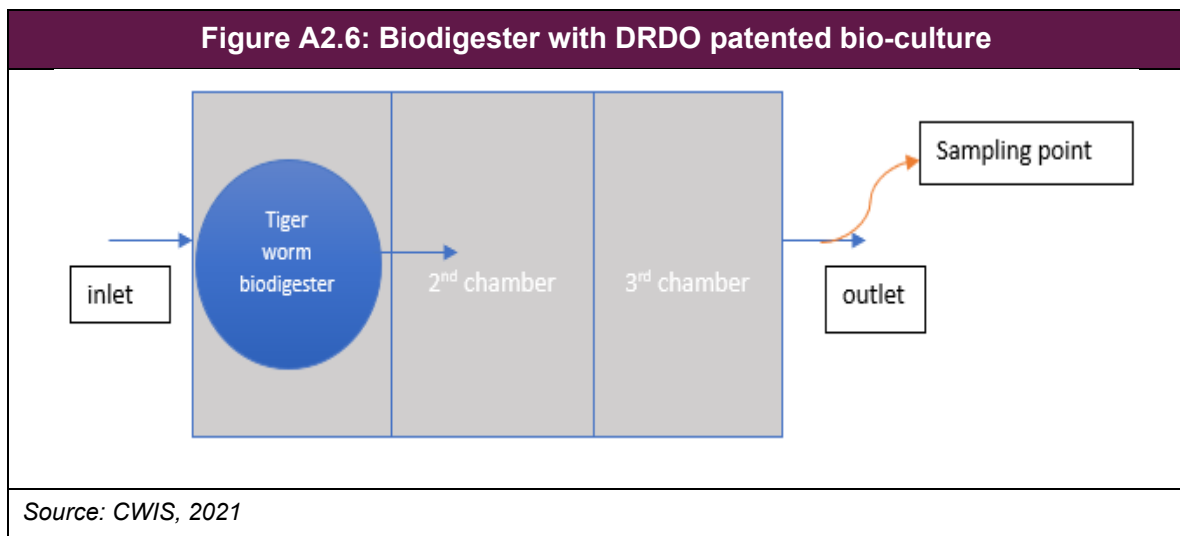
The digester was placed inside the prepared containment unit at the three sites. The schematic representation of DRDO biodigester is depicted in Figure A2.6.

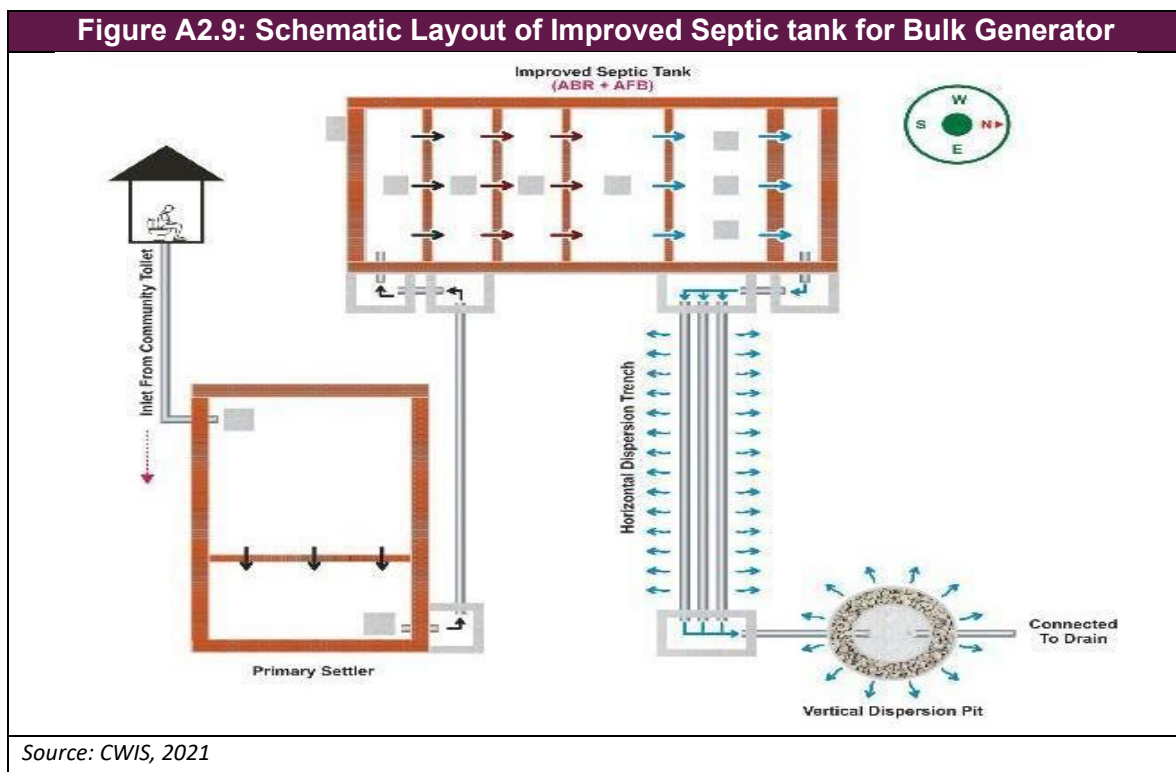
The improved septic tank has baffle walls and anaerobic filters based on the site-specific requirement. These initiatives will reduce de-sludging frequency, improve treatment efficiency and reduce the contamination around the area. Figure A2.10 depicts the schematic layout of the improved septic tank for bulk generator.
