Preventive Maintenance of Underground Sewerage Systems – Observation Note

Report | November 2025

CWIS
TRICHY

PREVENTIVE MAINTENANCE OF UNDERGROUND SEWERAGE SYSTEMS - OBSERVATION NOTE

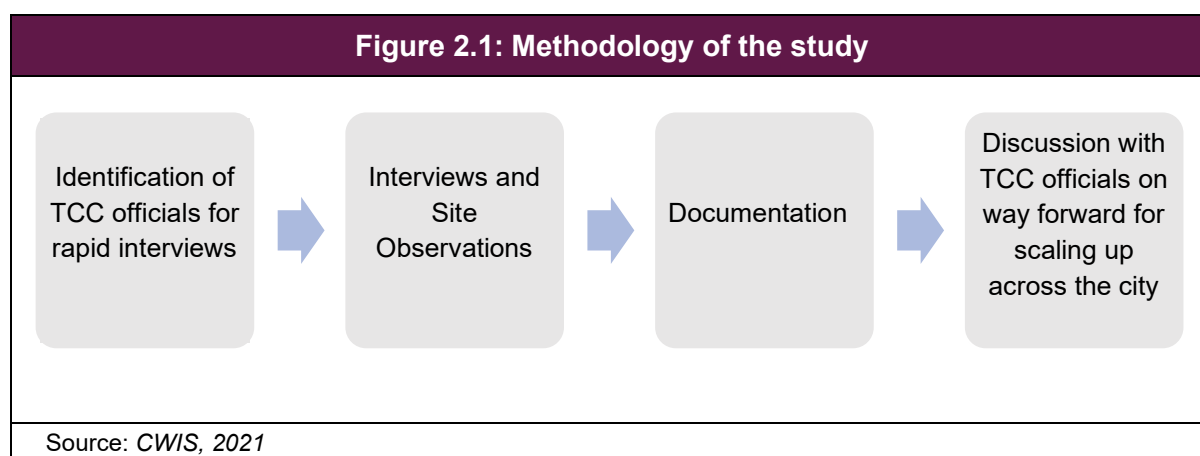
The CWIS team conducted rapid interviews and field assessments in November 2021. Interviews with four AEEs, one JE, and a sanitation worker were conducted. Conversations with the JE highlighted the

challenges and good practices followed in the preventive maintenance of UGSS. Site visits were undertaken to understand the ground conditions and effectiveness of preventive actions taken by TCC. Furthermore, second-level interviews with were conducted with the JE to verify the issues, as depicted in Figure 2.1.

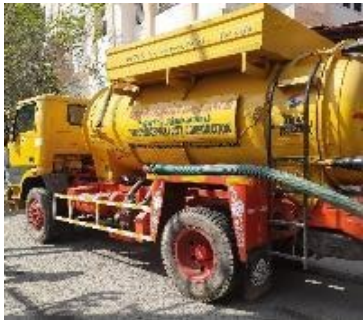
Table A2.1: TCC mechanical resources for maintenance of underground sewerage system			
Sl. No.	Description	Number of vehicles	Image
1	De-sludging vehicles – 6KL	2

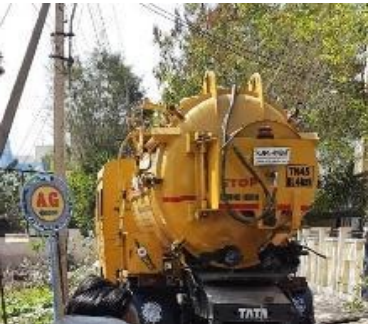
2	Blockage removal vehicle - Jetting machine	4

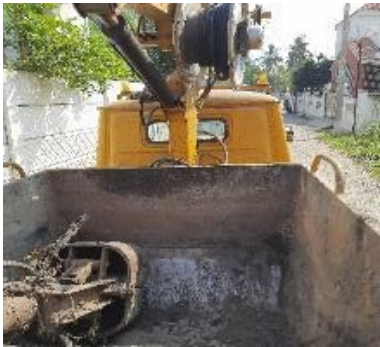
3	Small-sized grit or silt removal vehicle with cleaning arrangement	4

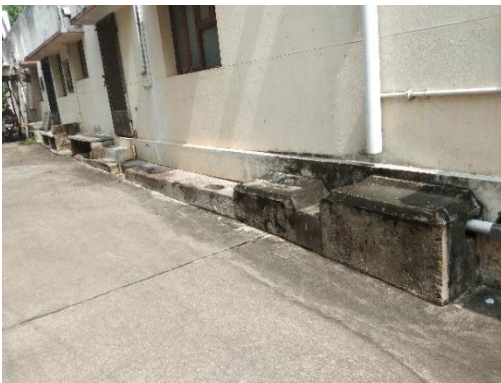
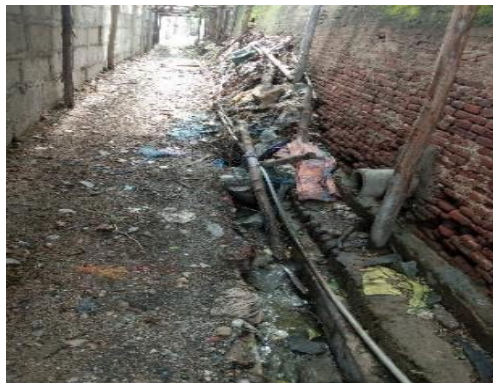
Figure A3.1: Observations from site visit	
Scum layer inside the underground drainage manhole	Open manhole (access open removed)

Progress of underground sewerage system revamping work

Increase in the height of UGSS connection by shallow sewer connections (6 Feet Sandhu, Srirangam)
